Report of
Condition Assessment and Reserve Study
for
WESTERLEY HOMEOWNERS ASSOCIATION
Sterling, Virginia

March 20, 2005

SUBJECT: REPORT OF CONDITION ASSESSMENT AND RESERVE STUDY
Westerley Homeowners Association
Sterling, Virginia
FEA Project No.: 01.2004.4008

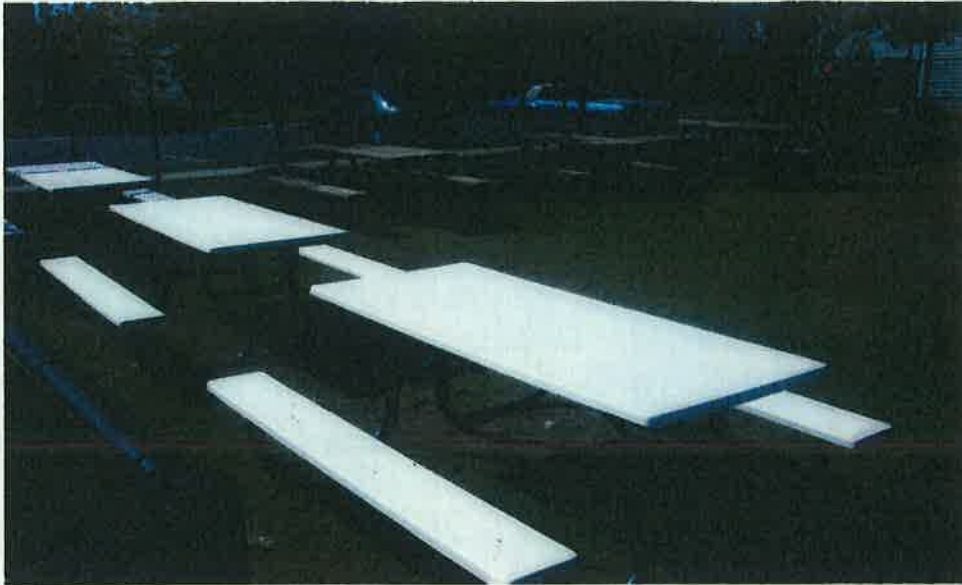
The pool furniture appeared to be in good condition. The picnic tables and garbage cans were also in good condition. The lifeguard stands were observed to be in good condition.

PHOTOGRAPH 4:
Picnic Tables Near Pool
Area

- 1.3.g - We recommend that replacement of the picnic tables and garbage cans at the pool area are budgeted for replacement every 15 years. Our opinion of cost to replace the tables and garbage cans is \$7,000.

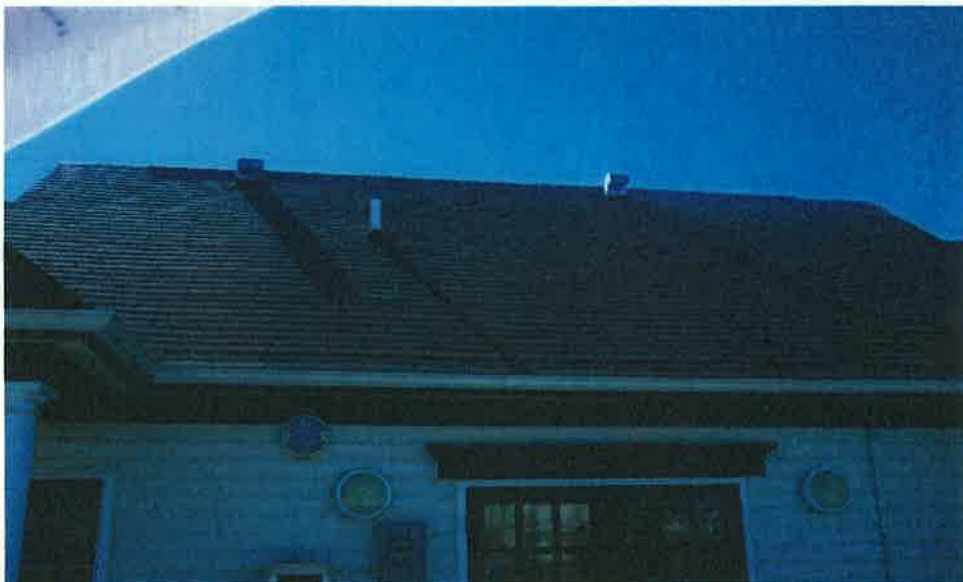
The bathhouse was in good condition. No leaks or staining were noted on the exterior of the building. The bathhouse roof appeared to be in good condition. Gutters and downspouts appeared to be functional, but were stained. This may indicate that the gutters overflow during heavy rains. The vinyl siding appeared to be in good condition.

PHOTOGRAPH 8:
Bathhouse Roof

- 1.3.k - The roofs should have an estimated useful life of 20 years. Our opinion of cost to replace the roof is \$6,000, including replacement of gutters and downspouts. Our opinion of cost also includes removal of the existing roof.

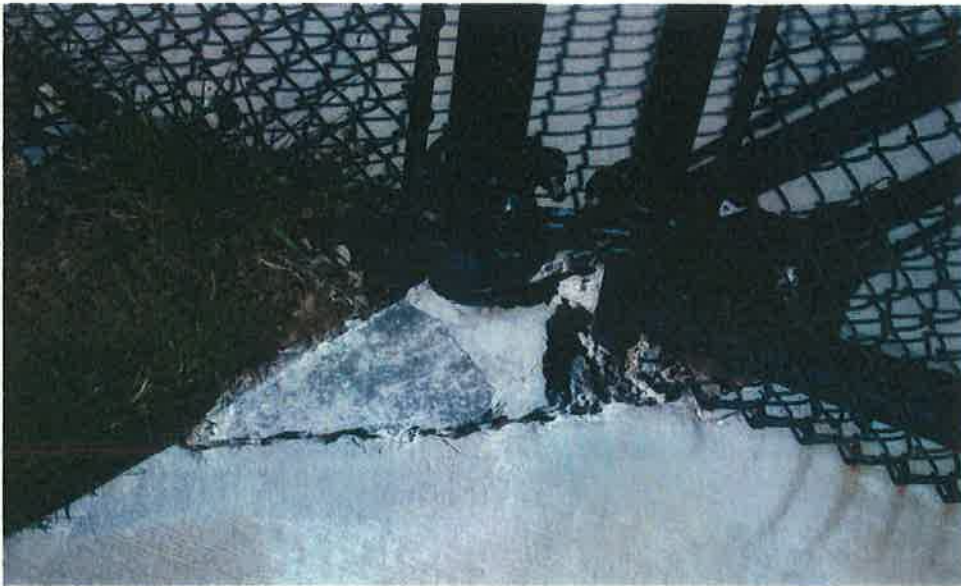
Fencing around the pool appeared to be in good condition. Concrete surrounding the pool was in fair condition. We observed one area of severe deterioration near one of the fence posts (reference Photograph 13 Appendix D). Elsewhere, we observed a number of cracks that had previously been routed and sealed (reference Photograph 14 in Appendix D). No settling of the pool deck was observed. Coping stones around the edges of both pools appeared to be in good condition. The pool covers and attachment anchorages appear to be in good condition, and reports from the property management company indicate the pool covers were replaced in February 2004.

PHOTOGRAPH 13:
Severe Deterioration of
Concrete in Pool Area

- 1.3.a - The chain-link fences at the pool area should have an estimated useful life of 20 years. The reserve tables include a lump sum of \$9,500 to replace the fences in 2017.
- 1.3.b - The reserve tables include an allowance of \$3,450 every five years to repair or replace cracked, damaged, or settled sections of the concrete pool deck. The first cycle of repairs is projected in 2005. This is based on replacing 10% of the total concrete area every five years. Periodic routing and sealing of cracks that develop is considered a maintenance issue.

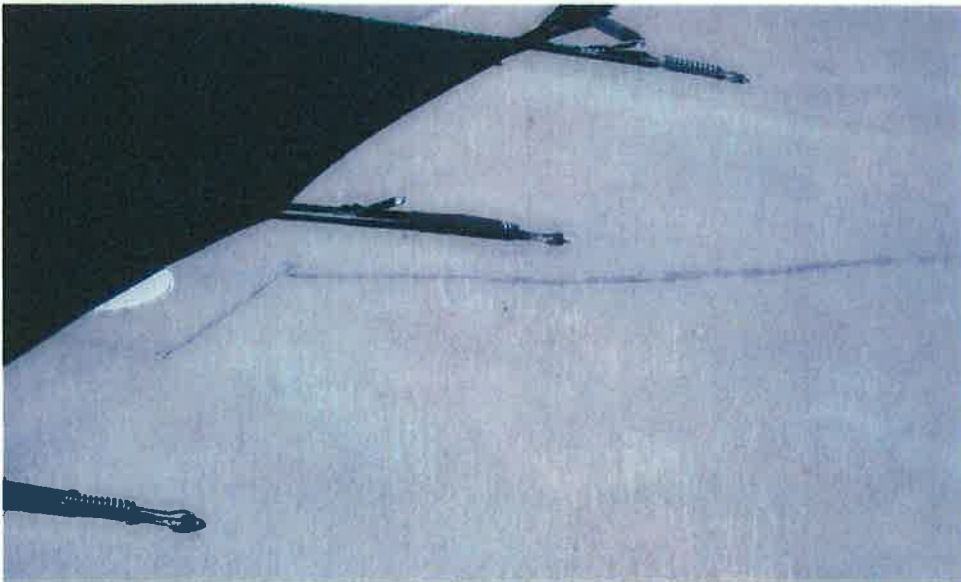
PHOTOGRAPH 14:
Concrete Pool Deck with
Previously Sealed Crack

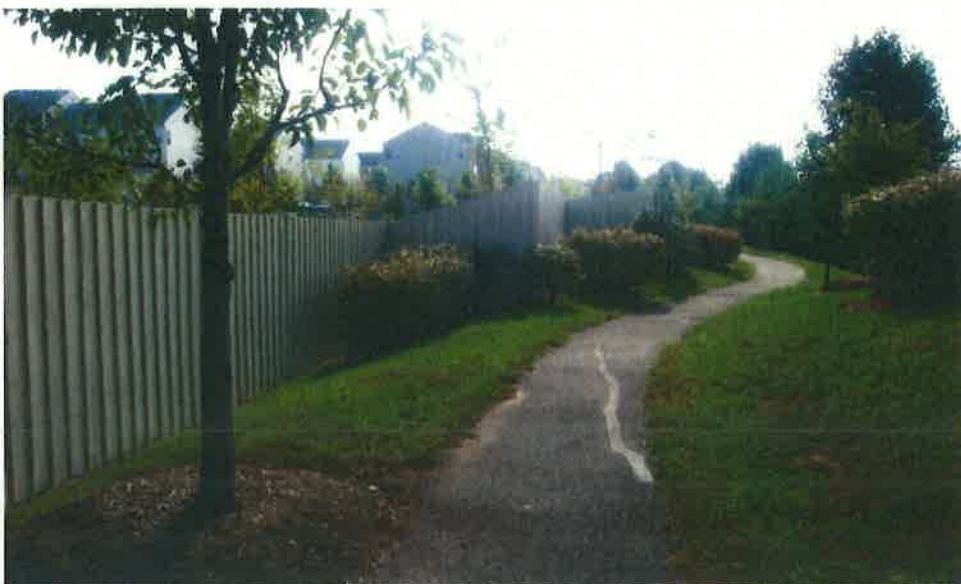
Asphalt foot paths approximately four feet wide are found throughout the community (reference Photograph 15 in Appendix D). A total of about 1,350 linear feet of pathways were observed during our site visits.

Asphalt walking paths in the community were in fair condition. Prior crack sealing work has been performed and several areas were cracking and showing minor signs of deterioration.

PHOTOGRAPH 15:
Asphalt Foot Path and
Sound-Attenuation Fence

- 2.3.a - Rather than scheduling a full replacement of the asphalt footpath, we have included an allowance in the reserve tables for periodic repairs or replacements to the footpath. The reserve tables include an allowance of \$1,500 every three years for necessary asphalt repairs.

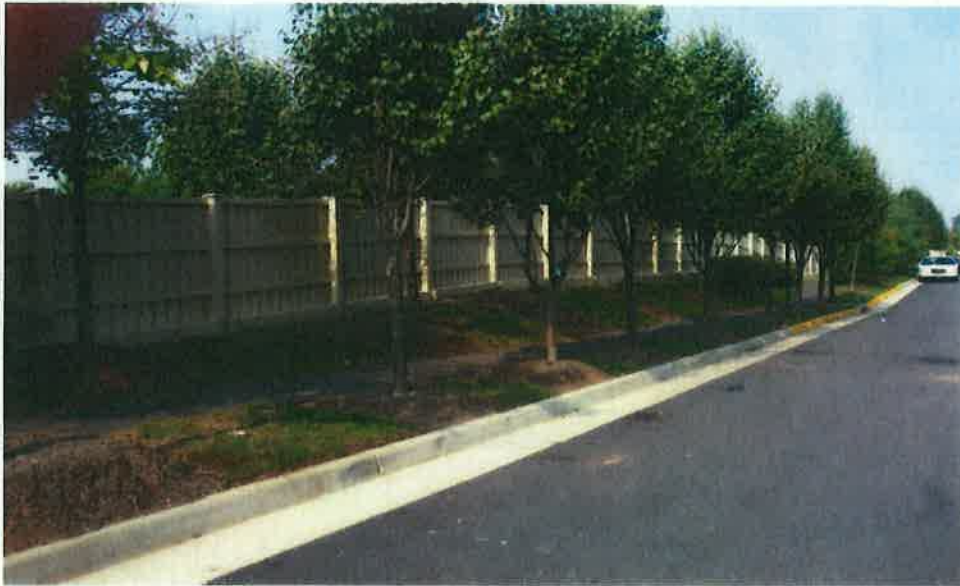
The sound-attenuation fence was in good condition, and it was reported that boards were replaced, and sealing and painting were performed in 1999. No signs of cracking were observed.

PHOTOGRAPH 16:
Sound Attenuation Fence

- 2.3.c - The reserve tables include an allowance for repairs, and sealing and painting of the sound-attenuation fence. Our opinion of cost for the repairs and refinishing is \$3,000, and we have included it in the reserve tables every seven years.

- 2.3.d - The reserve tables include a sum of \$15,000 to replace the sound-attenuation fence in 2017.
- 2.3.e - The reserve tables include a sum of \$11,700 for replacement of the modular block retaining wall in 2027.

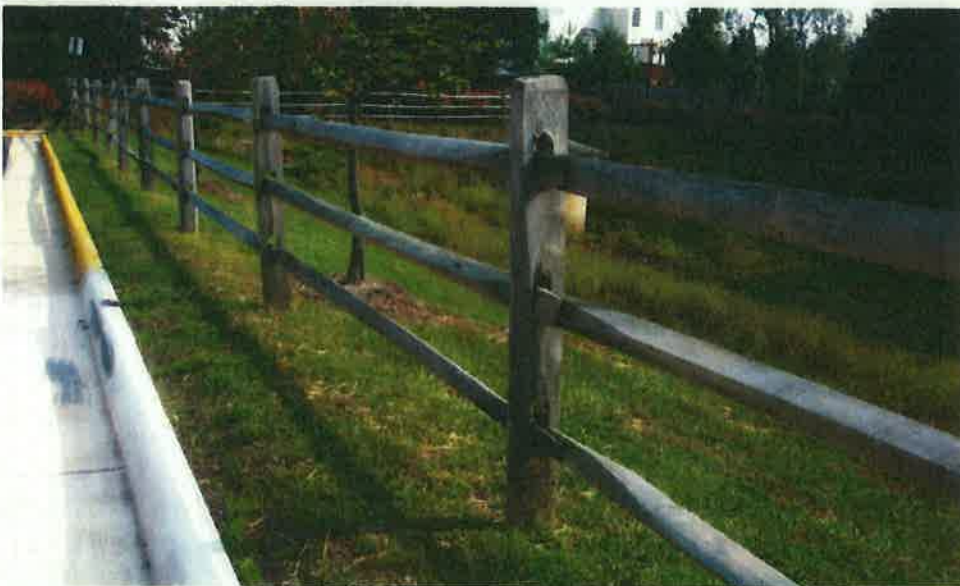
The split-rail fencing lining the storm water retention ponds was observed to be in fair condition. Instances of some splitting in the wood and slight deterioration were observed, but did not appear to be critical to the integrity of the fence.

PHOTOGRAPH 17:
Split-Rail Fencing at
Retention Pond

- 2.3.b - The reserve tables include a sum of \$10,875 to replace the split-rail fencing throughout the community in 2017. Minor repairs to the fencing are considered an operational expense.

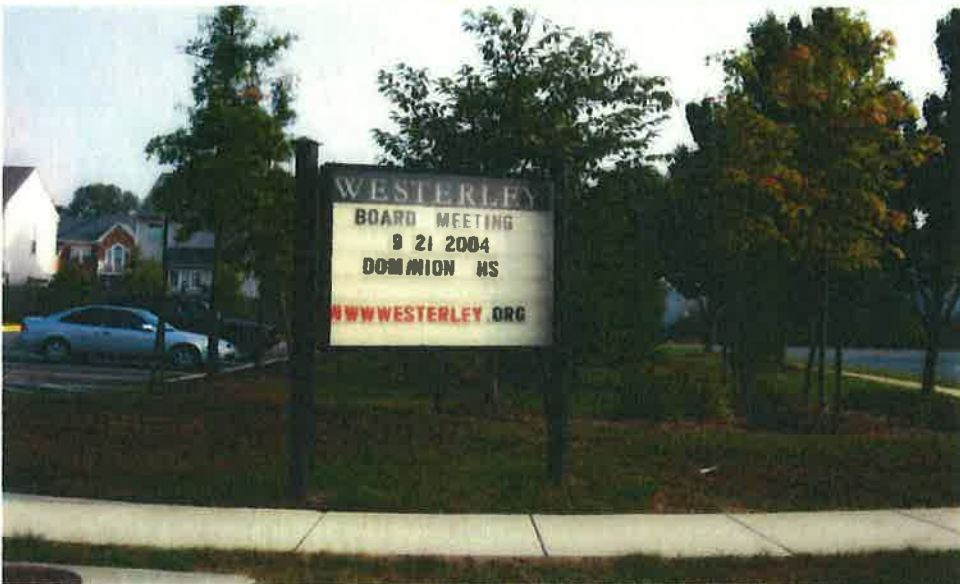
The metal community information board appeared to be in fair condition. Some corrosion was noted on the metal posts, and the viewing window appeared to have some discoloration.

PHOTOGRAPH 20:
Community Information Board

- 2.3.n - An allowance of \$2,000 is included in the reserve tables every 15 years, for the replacement of the community information board.
- 2.3.o - An allowance of \$1,200 is included in the reserve tables for replacement of pet stations after 15 years of use.

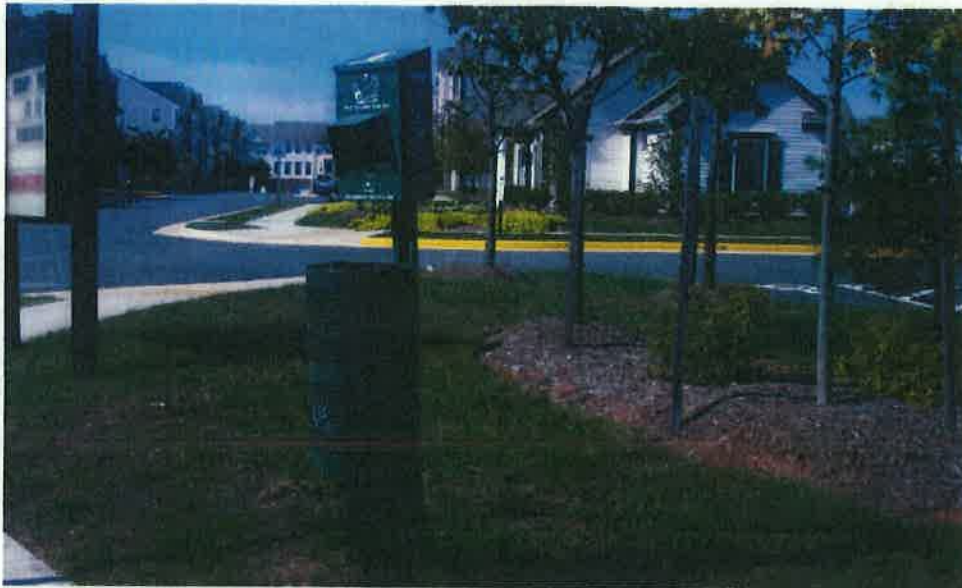
We observed three "pet stations" within the community. Each pet station consists of a pole-mounted wastebasket, above which is mounted a dispenser providing plastic baggies (reference Photograph 22 in Appendix D).

Pet stations appeared to be in good condition.

PHOTOGRAPH 22:
Pet Station

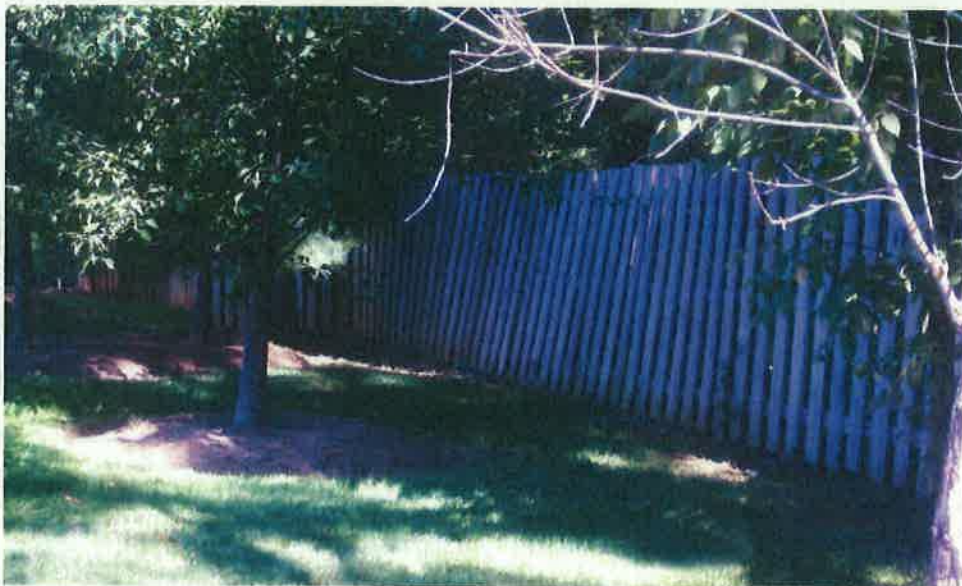
The 6-foot-high wood fence that runs along the northeast of the Westerley property was in overall fair condition. It appeared that the fence was installed before the Westerley community was developed. A significant amount of split wood was observed and sections of the fence were leaning (reference Photograph 23 in Appendix D).

PHOTOGRAPH 23:
Leaning Wood Fence at
Stormwater Retention
Pond in Single-Family
Home Area

- 2.3.l - We recommend budgeting for the replacement of the wood fence located at the northeast end of the property around 2006. Our opinion of cost to replace the fence is \$8,325.

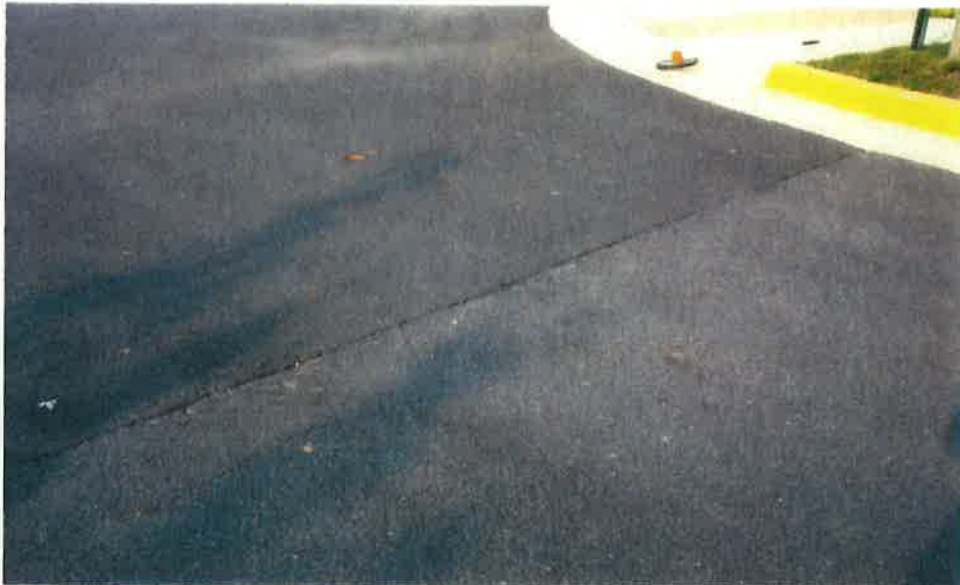
The Townhouse community asphalt paved areas were in good condition. No major cracking or failures were observed. Some minor cracking was seen along the joints of the various sections of the streets (reference Photograph 25 in Appendix D). In addition, several patches were located along the roadway sections (reference Photograph 26 in Appendix D).

PHOTOGRAPH 25:
Example of Minor Asphalt
Cracking at Joints

3.3.a - The townhouse community pavement should be seal coated and re-stripped every five years. The community was developed around 1997 to 2001, and it appeared that the asphalt had been seal coated sometime between development and our site visit. Our opinion of cost to seal coat and re-stripe the townhouse streets and parking areas is \$11,900. We recommend budgeting for this project beginning in 2007 and every five years thereafter. This cost should cover minor patching and crack filling. Seal coating and re-striping is not scheduled in 2017 due to the projected asphalt overlay project.

3.3.b - Periodic full-depth asphalt repairs are included in the reserve tables every five years. These repairs typically involve removing failed pavement, improving the sub-grade if necessary, and replacing the failed asphalt. The tables include an allowance to repair approximately 595 square yards of pavement, or about 5% of the total pavement area, every five years. Our opinion of cost for the full-depths repairs is \$17,850.

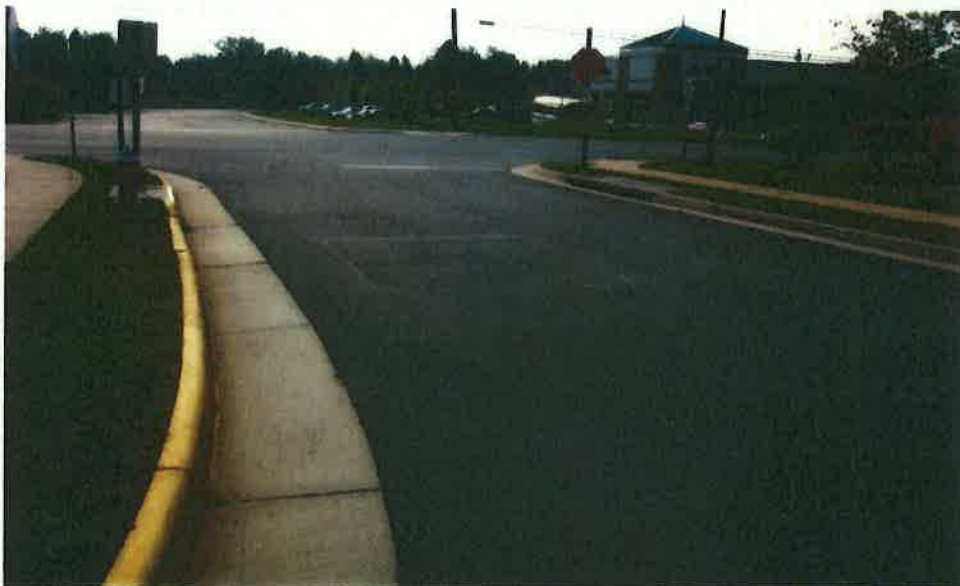
PHOTOGRAPH 26:
Asphalt Patch in
Townhouse Community

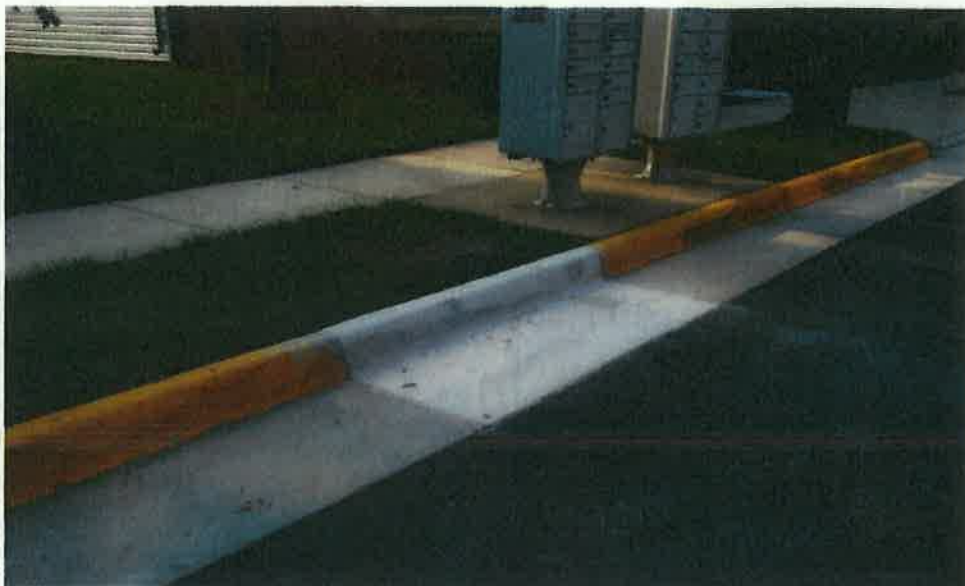
PHOTOGRAPH 28:

Replaced Curb Section in
Townhouse Community

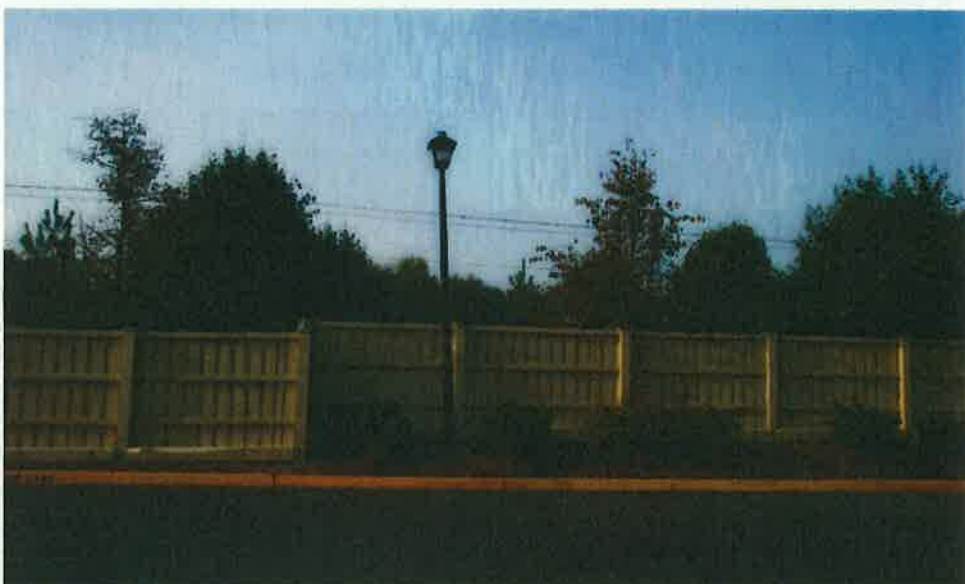
PHOTOGRAPH 29:

Lighting Fixture Beginning
to Lean in Townhouse
Community

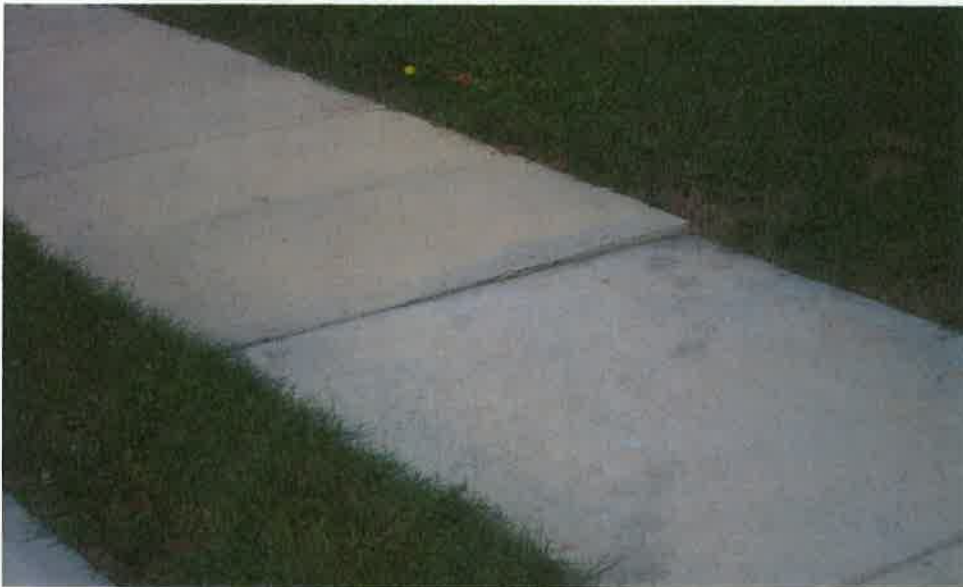
PHOTOGRAPH 32:

Settled Sidewalk Section in
Single-Family Home
Community

- 4.3.a - Concrete sidewalks will typically be replaced on an as-needed basis rather than all at once. The reserve tables include an allowance of \$4,100 every three years to replace damaged or settled concrete sidewalk sections in the townhouse community. This allowance is based on budgeting for the replacement of approximately 2% of the total sidewalk area at our opinion of cost of \$6 per square foot. The allowance is scheduled to begin in 2006.
