Report of
Reserve Study Update
for

**WESTERLEY HOMEOWNERS
ASSOCIATION**
Sterling, Virginia

FEA Report No.01.2008.005561
June 9, 2008

SUBJECT: REPORT OF CONDITION ASSESSMENT AND RESERVE STUDY
Westerley Homeowners Association
Sterling, Virginia
FEA Project No.: R01.2008.005561

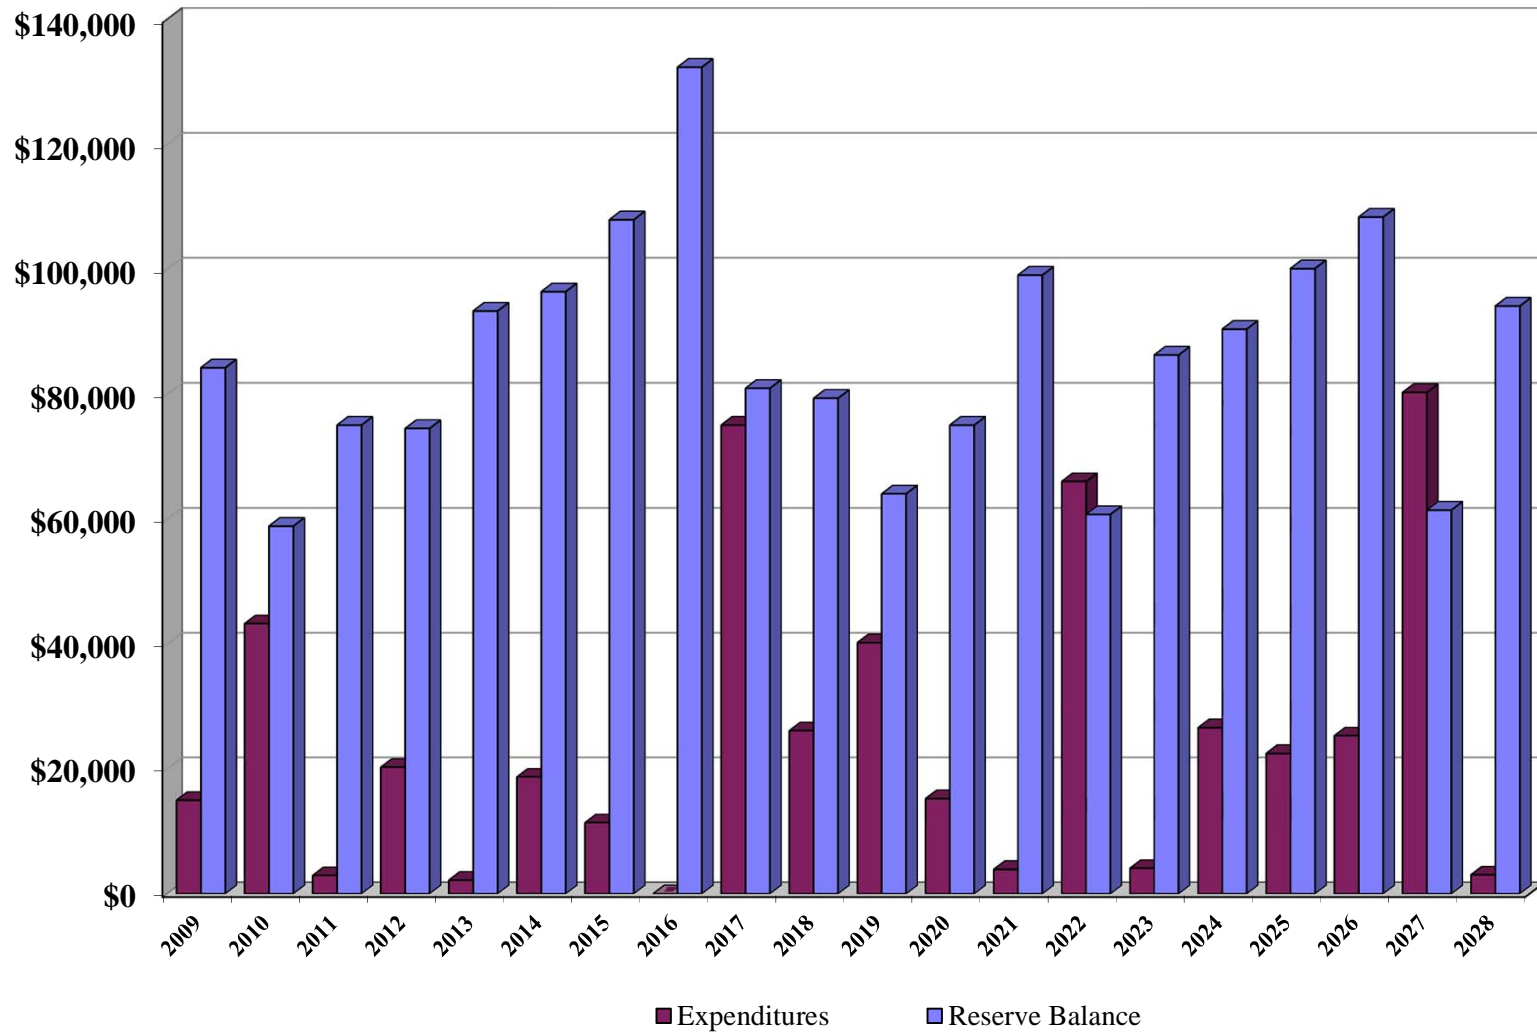
Cash Flow Summary
Table 4 (Recommended Funding)
COMMON RESERVES

2017	\$397,734	\$132,380	\$22,020	\$26,890	\$1,718	\$75,117	\$81,001	20%	
2018	\$406,484	\$81,001	\$22,901	\$27,451	\$1,645	\$26,152	\$79,396	20%	
2019	\$415,427	\$79,396	\$23,817	\$27,281	\$1,174	\$40,277	\$64,110	15%	
2020	\$424,566	\$64,110	\$24,770	\$27,605	\$1,466	\$15,245	\$75,100	18%	
2021	\$433,906	\$75,100	\$25,761	\$27,910	\$2,136	\$3,895	\$99,101	23%	
2022	\$443,452	\$99,101	\$26,791	\$29,554	\$991	\$66,075	\$60,808	14%	
2023	\$453,208	\$60,808	\$27,863	\$29,413	\$1,702	\$4,069	\$86,305	19%	
2024	\$463,179	\$86,305	\$28,977	\$30,422	\$1,791	\$26,611	\$90,462	20%	
2025	\$473,369	\$90,462	\$30,136	\$30,892	\$2,039	\$22,487	\$100,150	21%	
2026	\$483,783	\$100,150	\$31,342	\$31,434	\$2,244	\$25,334	\$108,402	22%	
2027	\$494,426	\$108,402	\$32,595	\$32,828	\$842	\$80,328	\$61,512	12%	
2028	\$505,304	\$61,512	\$33,899	\$32,259	\$1,755	\$3,024	\$94,142	19%

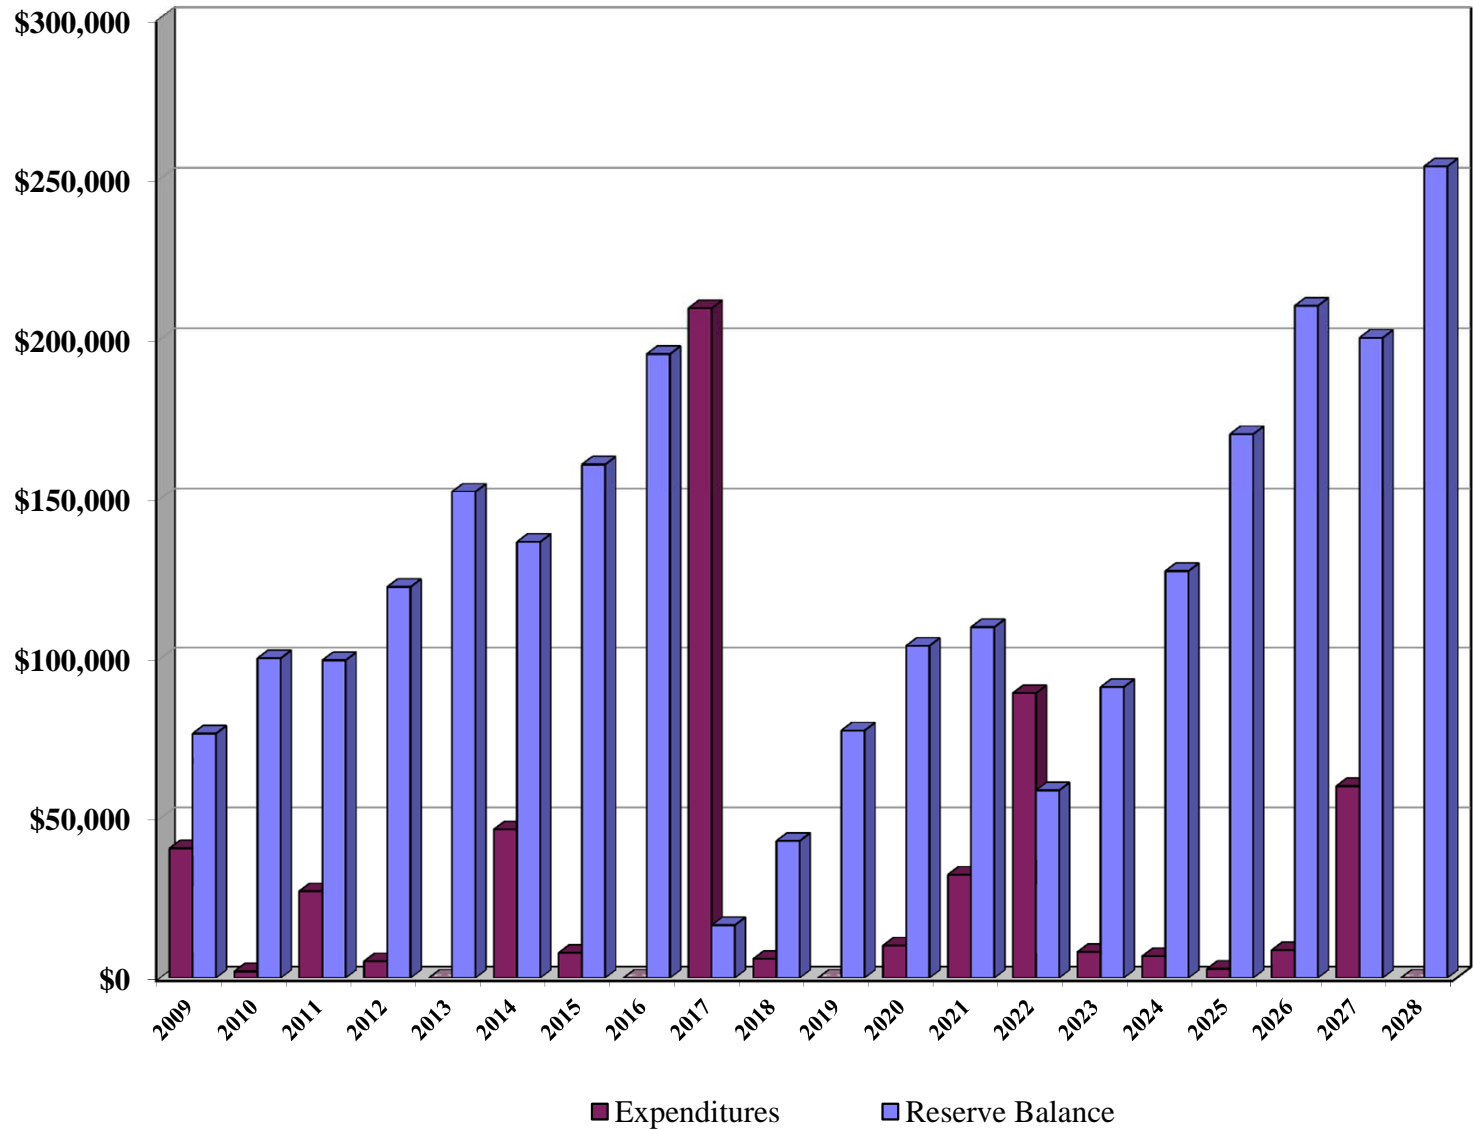
Cash Flow Summary
Table 4 (Current Funding)
COMMON RESERVES

2017	\$296,827	\$195,340	\$30,793	\$26,630		\$209,618	\$16,515	6%	
2018	\$303,357	\$16,515	\$32,025	\$26,760	\$317	\$5,960	\$42,896	14%	
2019	\$310,031	\$42,896	\$33,305	\$26,760	\$1,287		\$77,489	25%	
2020	\$316,852	\$77,489	\$34,638	\$26,982	\$2,020	\$10,164	\$103,983	33%	
2021	\$323,823	\$103,983	\$36,023	\$27,671	\$2,150	\$32,330	\$109,825	34%	
2022	\$330,947	\$109,825	\$37,464	\$30,322	\$620	\$89,173	\$58,736	18%	
2023	\$338,228	\$58,736	\$38,963	\$30,500	\$1,518	\$8,137	\$91,080	27%	
2024	\$345,669	\$91,080	\$40,521	\$30,648	\$2,529	\$6,791	\$127,338	37%	
2025	\$353,273	\$127,338	\$42,142	\$30,709	\$3,735	\$2,833	\$170,383	48%	
2026	\$361,045	\$170,383	\$43,828	\$30,899	\$4,851	\$8,686	\$210,375	58%	
2027	\$368,988	\$210,375	\$45,581	\$32,201	\$4,509	\$60,068	\$200,398	54%	
2028	\$377,106	\$200,398	\$47,404	\$32,201	\$6,012		\$253,814	67%

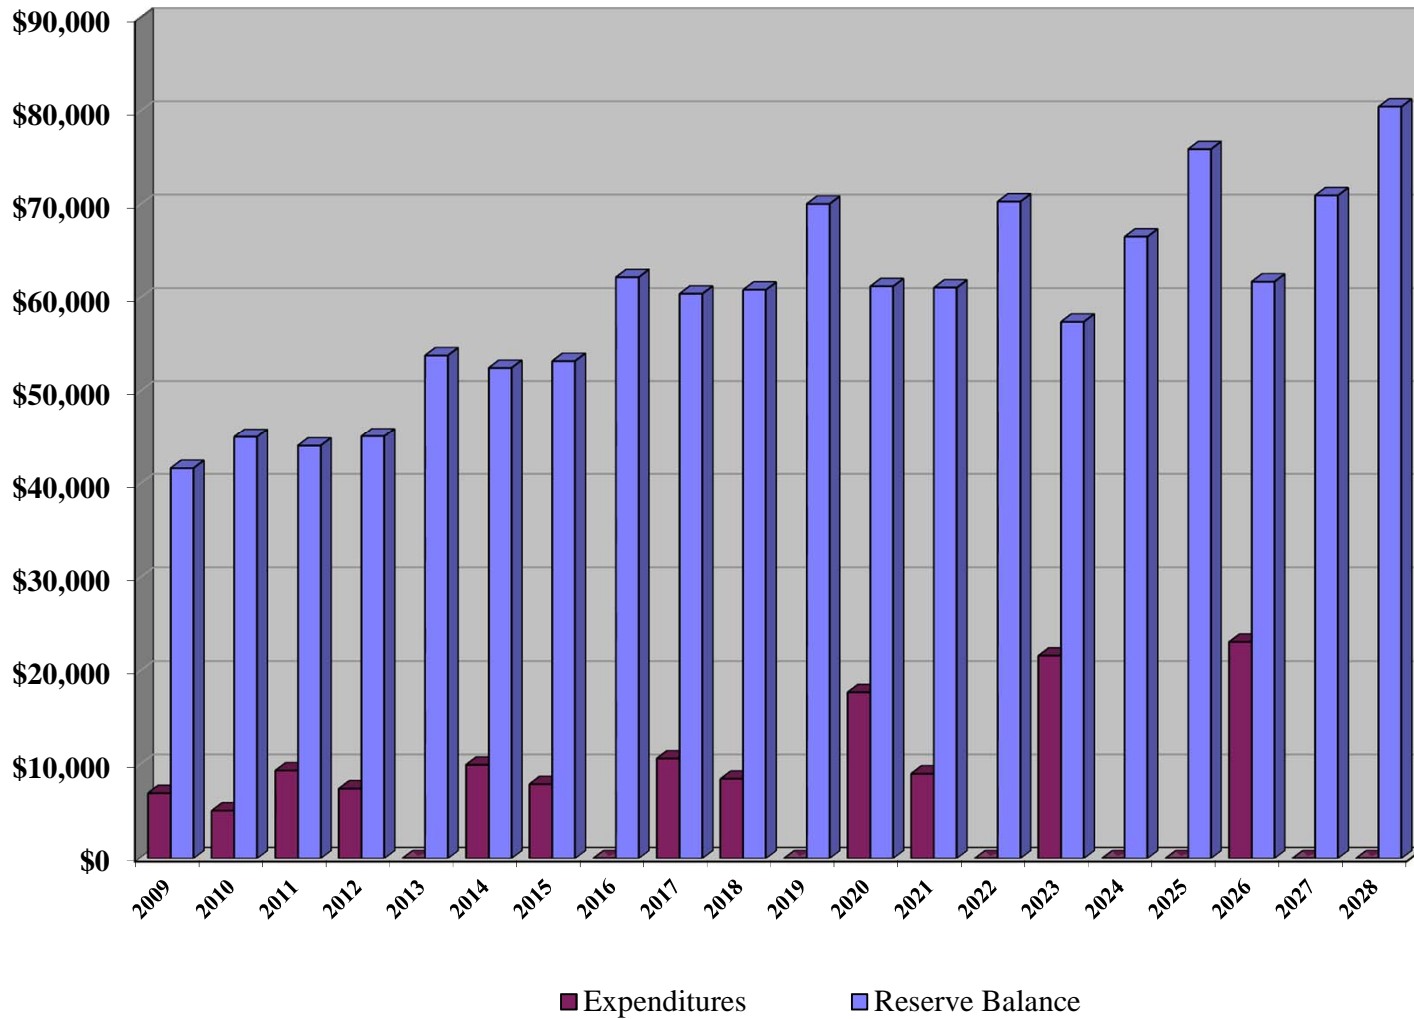
Cash Flow Summary
Table 4 (Current Funding)
SINGLE-FAMILY HOME RESERVES

2017	\$24,993	\$62,299	\$7,380	\$7,008	\$1,548	\$10,711	\$60,515	242%	
2018	\$25,543	\$60,515	\$7,380	\$7,194	\$1,560	\$8,514	\$60,941	239%	
2019	\$26,105	\$60,941	\$7,380	\$7,194	\$1,828		\$70,149	269%	
2020	\$26,680	\$70,149	\$7,380	\$7,578	\$1,571	\$17,786	\$61,313	230%	
2021	\$27,267	\$61,313	\$7,380	\$9,314	\$1,567	\$9,089	\$61,171	224%	
2022	\$27,866	\$61,171	\$7,380	\$9,314	\$1,835		\$70,386	253%	
2023	\$28,479	\$70,386	\$7,380	\$8,183	\$1,461	\$21,699	\$57,528	202%	
2024	\$29,106	\$57,528	\$7,380	\$8,183	\$1,726		\$66,634	229%	
2025	\$29,746	\$66,634	\$7,380	\$8,183	\$1,999		\$76,013	256%	
2026	\$30,401	\$76,013	\$7,380	\$8,688	\$1,586	\$23,162	\$61,816	203%	
2027	\$31,070	\$61,816	\$7,380	\$8,688	\$1,854		\$71,051	229%	
2028	\$31,753	\$71,051	\$7,380	\$8,688	\$2,132		\$80,562	254%
